DIFFICULTIES ENCOUNTERED AND SOLUTIONS DEVELOPED IN RESTORING MASONRY BUILDINGS - INVESTIGATION OF FIVE SIGNIFICANT BUILDINGS

Tom Hines

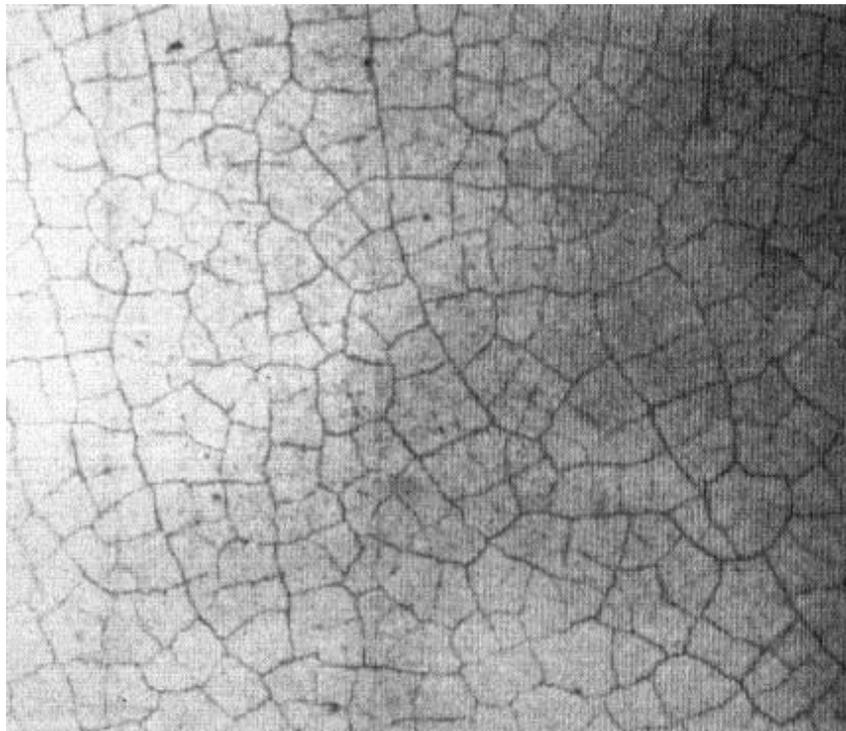
Figure 2 - Typical crazed conditions of terra cotta found on the building

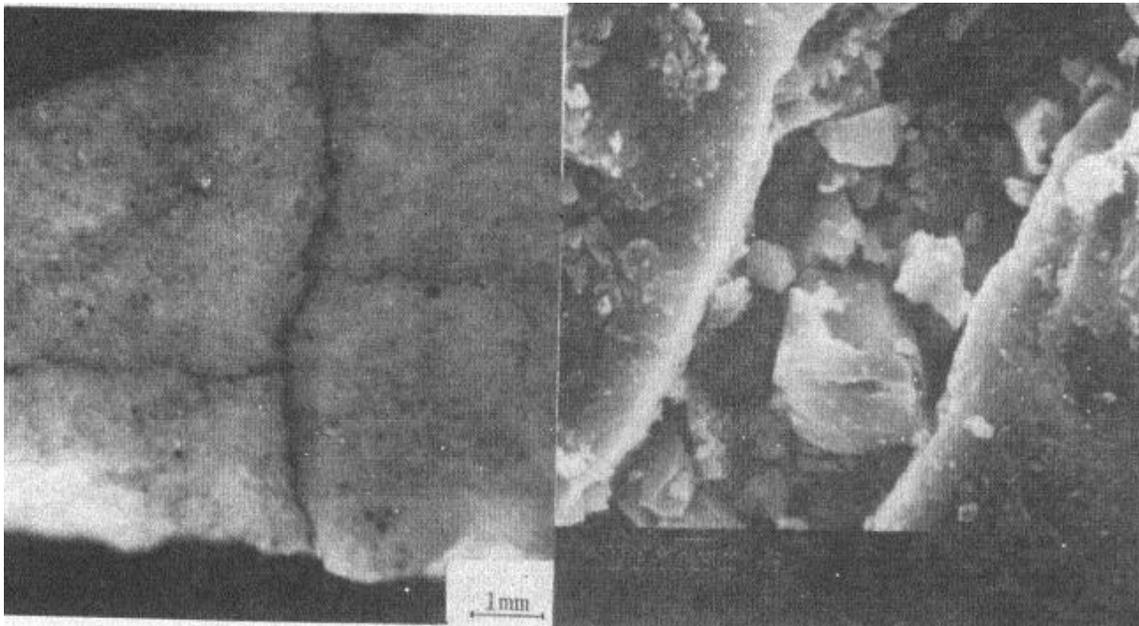
- ❑ examination of cross-section of the glaze surface of the original terra cotta samples indicated that many of the crazing cracks extended through the glaze and into the clay body of the stone. (When crazing cracks extend through the depth of the glaze, moisture permeance will not be resisted. Dirt particles may also penetrate into the clay body and cause discoloration [Figure 4], (6),

Figure 3 - Photograph on the left shows a typical crazing crack found on the samples. Photograph on the right is a 5000x magnification of a crazing showing the accumulated dirt particles.

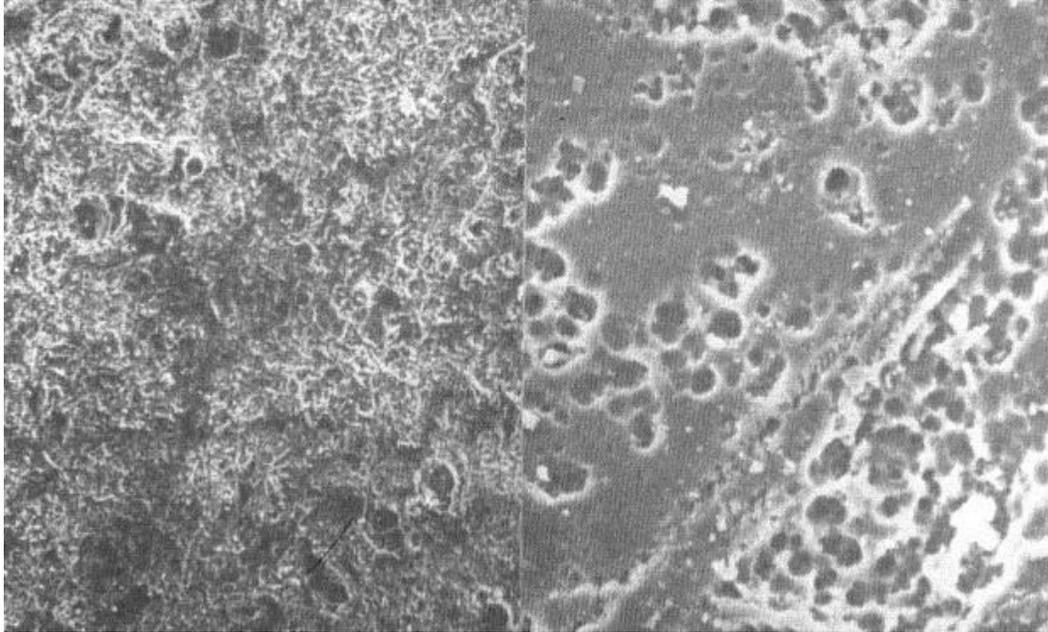
- ❑ examination of the uncracked surface glaze of the samples were found to be etched and eroded resulting from past cleanings with strong acid solutions [Figure 5],

Figure 5 - Micrographs of the uncracked glaze surface when viewed using 100x and 1000x magnification respectively.

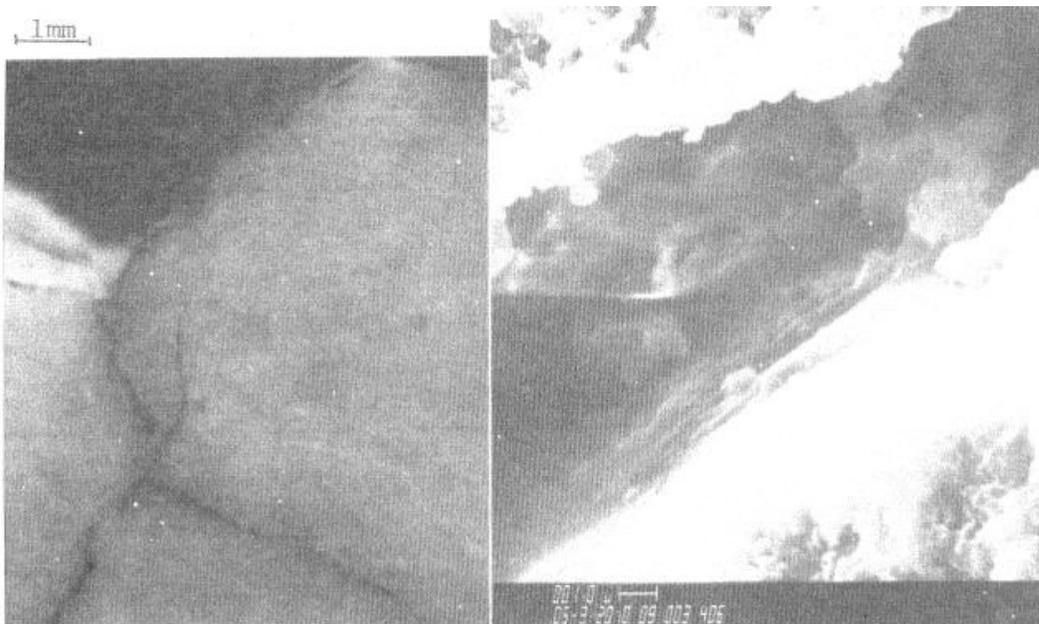
Upon completion of the testing, portions of the glaze samples "were magnified and examined [Figure 6]. Test results indicated the dirt was sufficiently removed and the glaze was not adversely affected. Such was also true for the replacement terra cotta and the polymer concrete stone.

Figure 6 - Close-up views of a terra cotta sample after cleaning. The photograph on the right is a crazing crack when viewed using 5000x magnification.

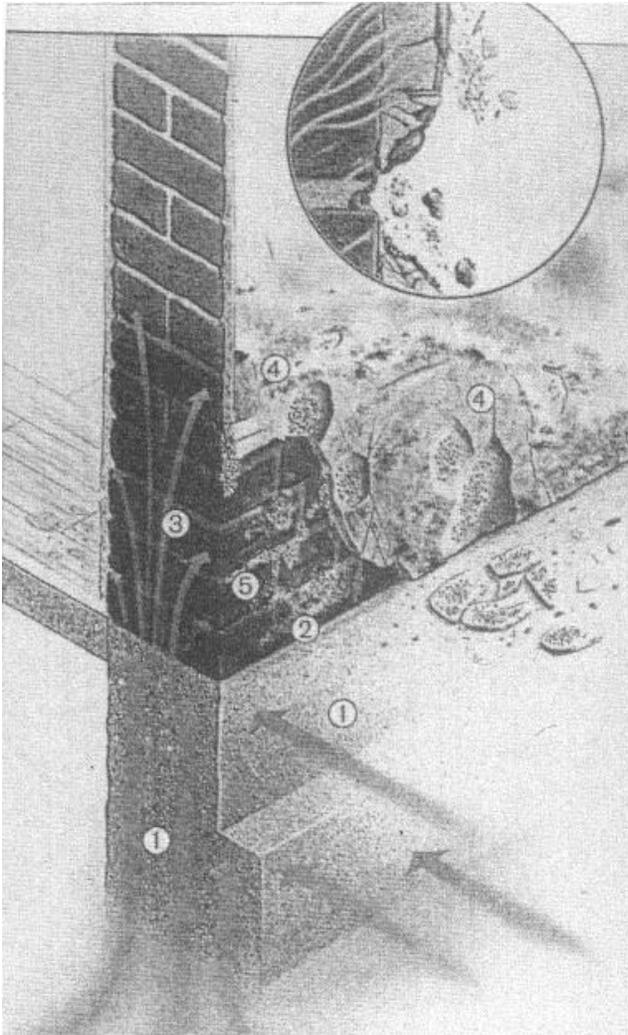
The hazards of using lime-cement plasters are [Figure 8]:

- salt content in the evaporation zone will increase, destroying that area over time,
- plaster is destroyed and has fallen off, the destruction on the masonry will continue,
- lime-cement plasters are anhydrous and will absorb and hold moisture.

1. Water has access to the foundation
2. Horizontal insulation missing or defective
3. Water and soil-salt entering masonry
4. Plaster and paint destroyed
5. Masonry is attacked

Figure 8 - Characteristics of normal lime-cement plaster under water load

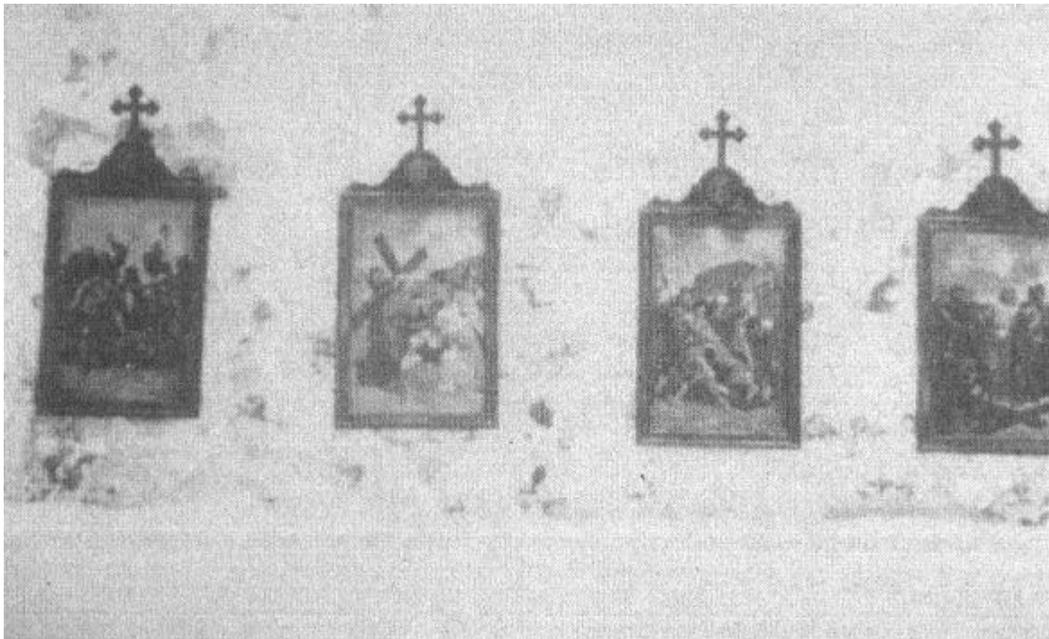
Figure 9 - Incorrect practice using a tight cement type plaster

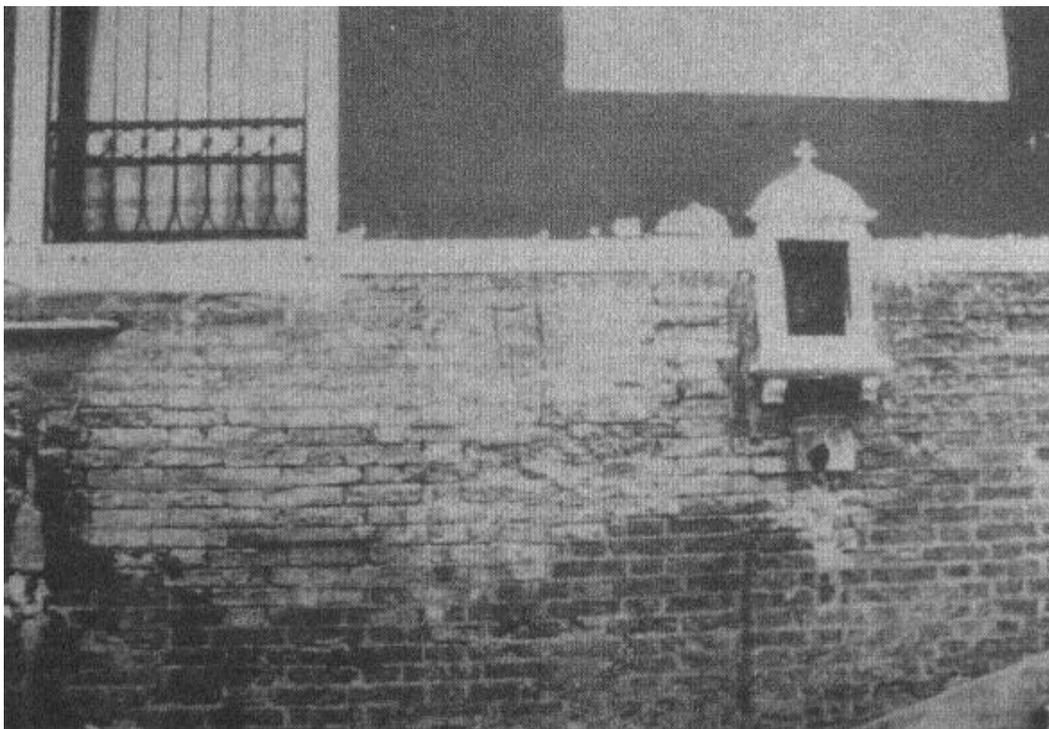
In Germany as in the United States, having the proper knowledge of material applications and the appropriateness of its use, is often assailed for less costlier methods. Prior to restoration, the wall of the Orthodox Monastery was improperly treated with a very hard and steam tight cement-plaster [Figure 9], or the application of so-called ventilation pipes, were utilized on damp masonry. Removal of the plaster from the masonry, leaving the wall exposed is likewise inappropriate. With this the effects of salts can directly affect the masonry. The damage and subsequent restoration will be more extensive and difficult to do. An example, from Venice [Figure 10], shows the negative effect of such an undertaking.

Figure 10 - Inappropriate practice - unprotected masonry

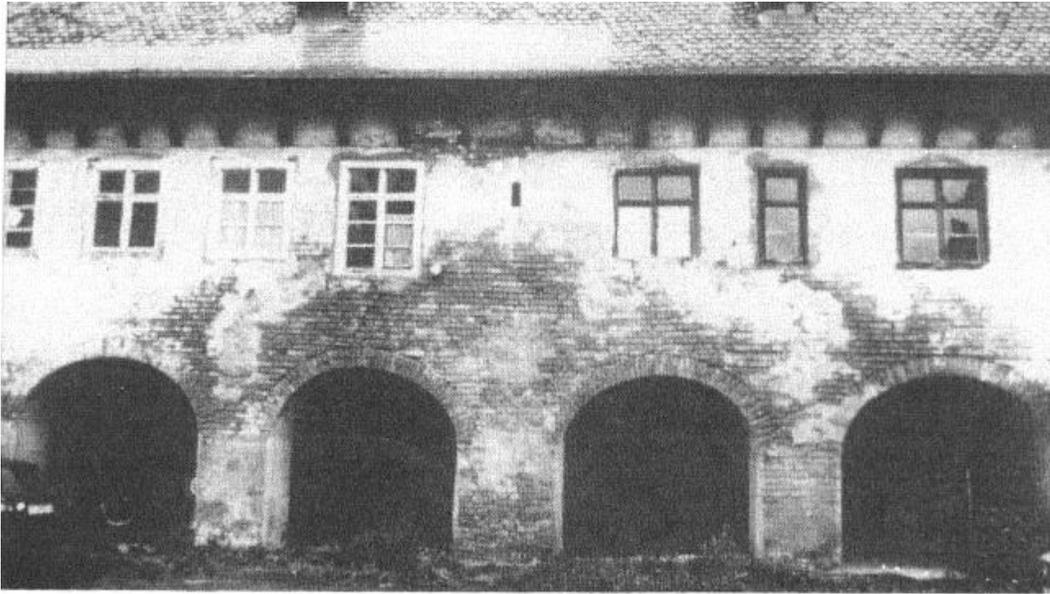
Work on the Orthodox Monastery in Praxis, Germany began with most of the exterior wall totally involved with rising damp and deterioration of the masonry [Figure 11]. Decaying efflorescent salts covered much of the surfaces and the internal pressures were spalling the brick, popping the plaster from the masonry and contributing to staining and damage to the internal surfaces. Upon completion of the researching the building's history, determining how the water and moisture was migrating into the masonry, work began to correct the problems.

Figure 11 - Inappropriate practice and maintenance on the Monastery

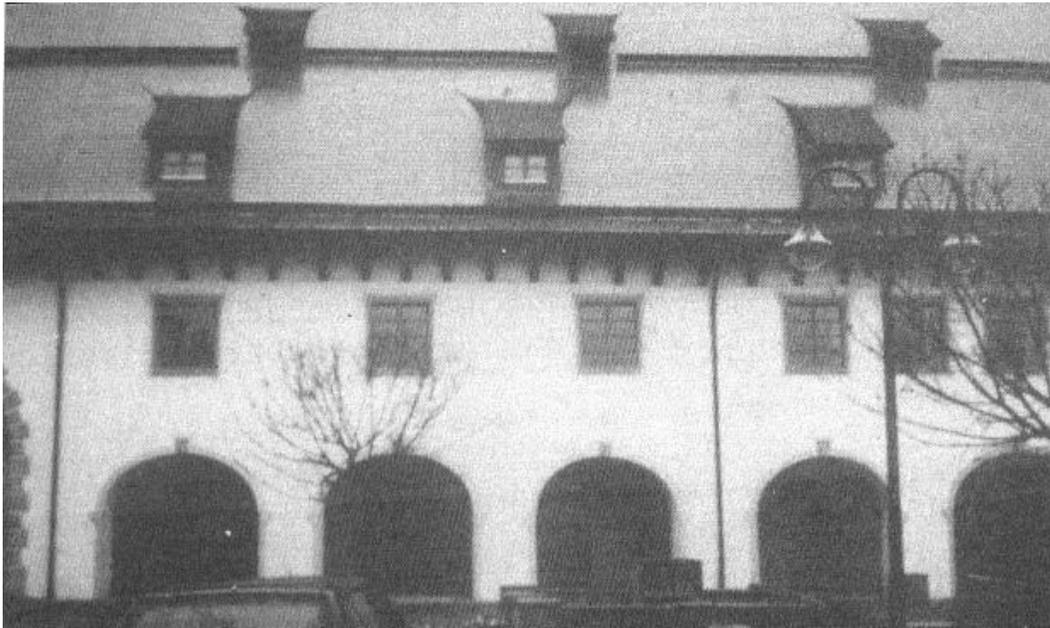
Figure 12 - Repair of the Monastery using re-development plaster

Horizontal insulation included the damp course, consolidation and replacement of deteriorated units. Vertical insulation included cleaning of the brick, application of the redevelopment plaster on the interior and exterior and repainting with vapor porous paint. Figure 12 is typical of the other elevations of the monastery. The interior plaster has functioned just as well.

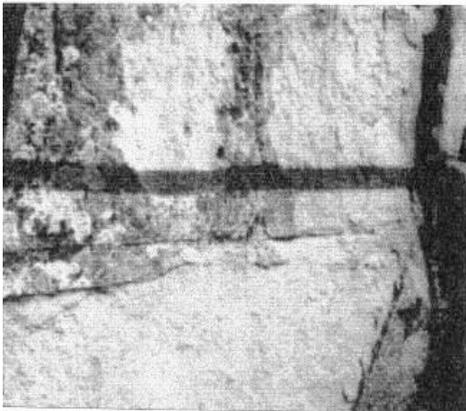
Close investigations of the tower structure and stones revealed critical information that would lead to several methods of non-destructive investigations. Figure 14a shows the severe deterioration of the stone. Figure 14b reveals the nature of the local cracks with individual stones. Figure 15 shows the major vertical crack in the South Wall (2).

Figure 14 - Left photograph shows stone deterioration. Right photograph shows local stone cracking

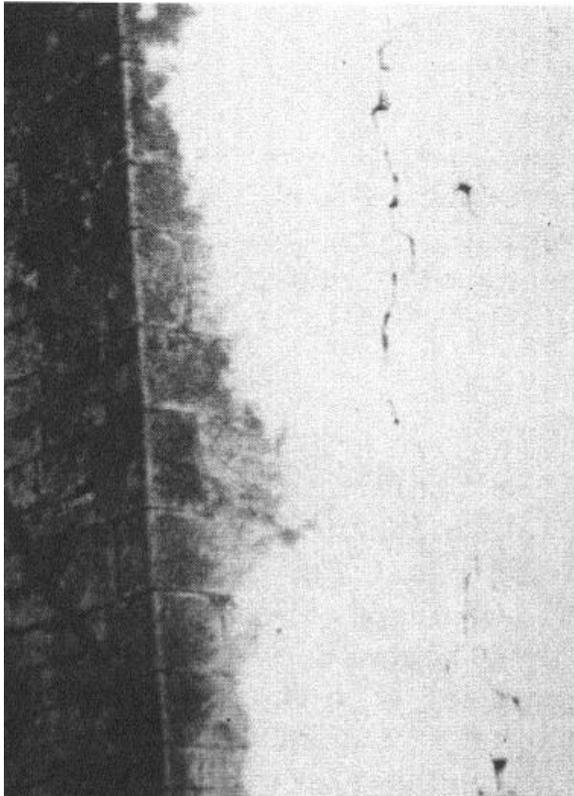
Figure 15 - Cracking of the South wall

- ❑ epoxy injections and horizontal steel tie rods to increase the compressive strength at each level of the tower - this will allow the walls to co-operate structurally,
- ❑ stainless steel bars and plates for ties passing through the masonry and for external anchoring devices - bolted connections are used and the ties are inserted in small holes drilled through the stones which will remain void so that the systems can be removed, if necessary [Figures 15&16].

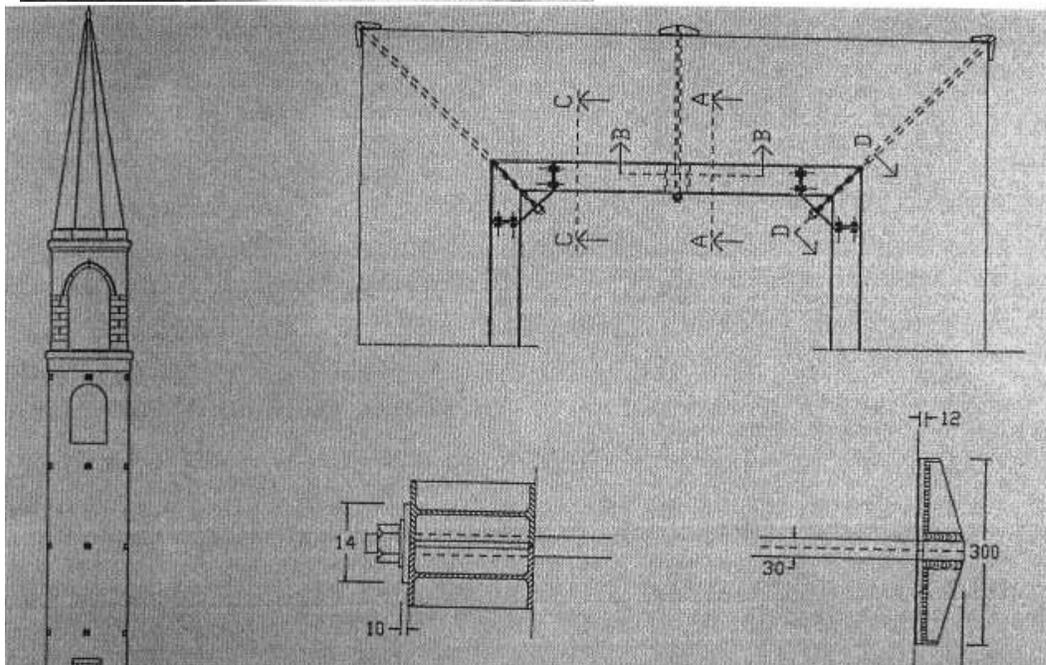
Figure 16 - General view and details of the steel work made for strengthening the bell tower.

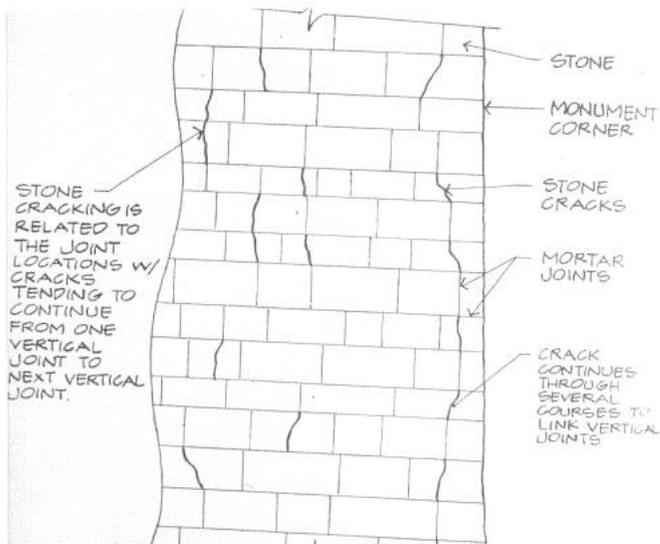
- exterior stone cracks started with vertical mortar joint, continued through one or two courses and ended with vertical mortar joint,
- alternating cracks with mortar joints continued through eight to ten courses at wall mid-face, [Figure 18],

- corner cracks of exterior stone, at the corners, follow similar pattern of starting and ending with vertical mortar joints,
- corner cracks, alternating with the mortar joints, were more extensive and continued through 20 or more courses [Figure 18],

Figure 18 - Exterior crack pattern

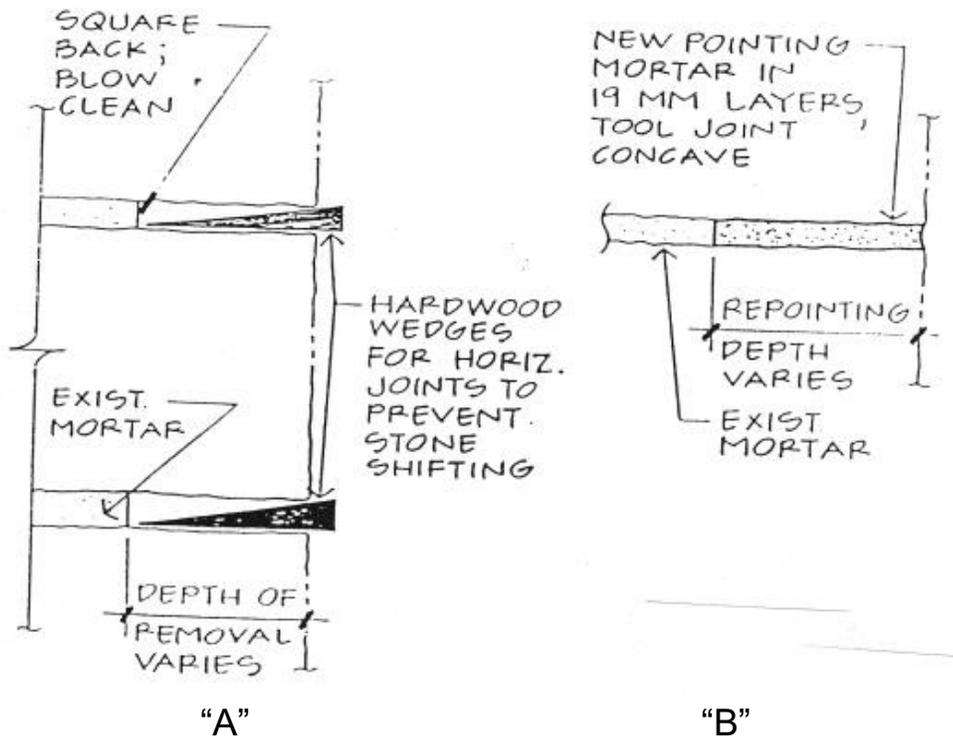
Figure 19 - "A" shows mortar removed.

"B" shows mortar repointing

- ❖ a grinder was used to saw-cut and weaken the hard repointing mortar
 - ❖ a pneumatic carving tool with a flat tip the broken mortar was removed [Figure 19]

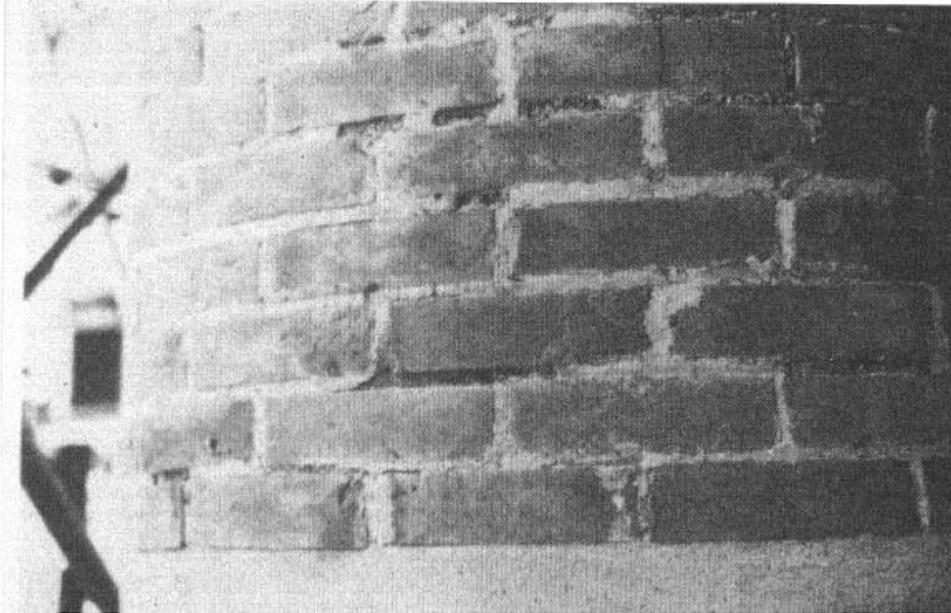
- Tuckpointing was required for the majority of the mortar joints,
- Found over the arched window heads and throughout the brick walls were cracks ranging from hairline to over one inch [Figure 21],

Figure 21 - Brick pilaster before tuckpointing phase

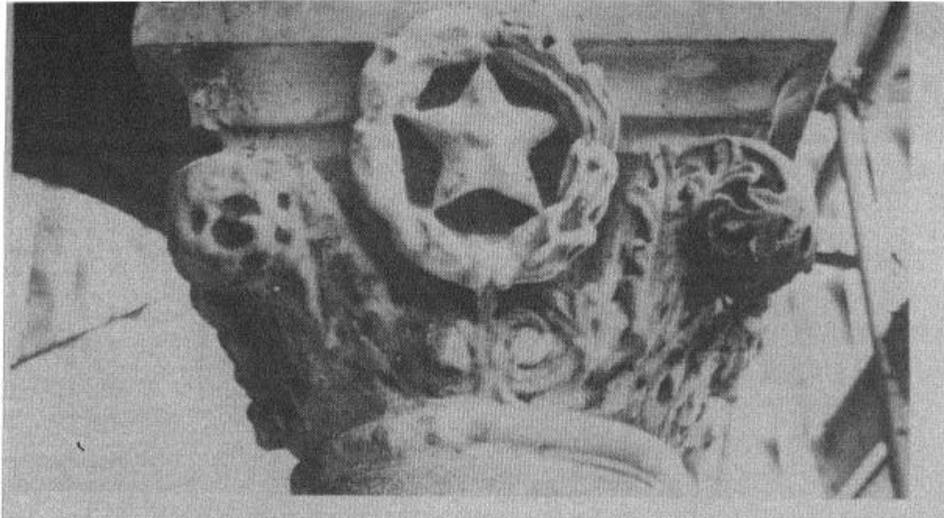
- Exterior stucco masonry experience deterioration from internal moisture and atmospheric erosion from the salt air,
- Spalling and cracking occurred from expansion movement of adjacent masonry caused by trapped moisture. Stucco masonry was used as artificial sandstone.
- Bleaching and discoloration occurred over time,
- Many of the decorative elements had been smoothed by the salty winds - the column capitols of the entry porch were particularly effected [Figure 22].

Figure 22 - Column capital smoothed by ocean winds

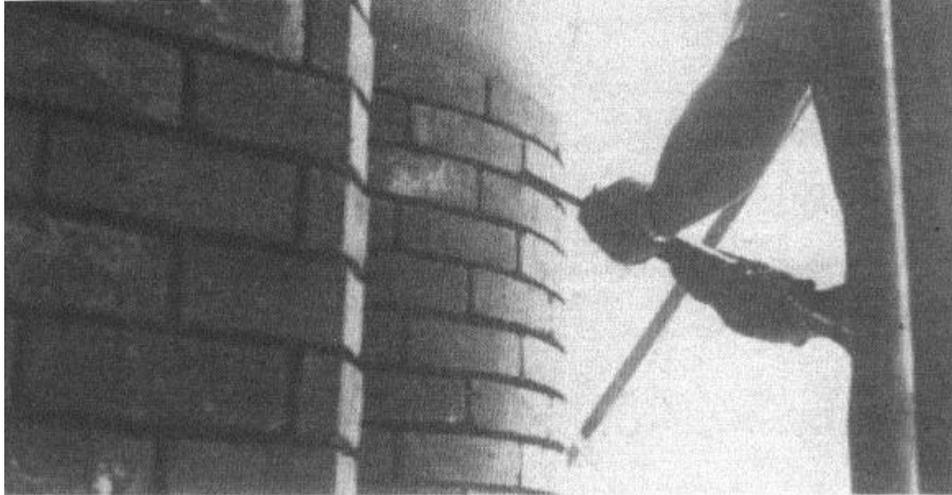
Figure 23 - Removing mortar with power chisel. Preparing the wall for tuckpointing phase

- Cleaning and preparation of the brick joints was carried out using hand and power tools [Figure 23]. The joints were raked one inch deep and the loose mortar was washed out during a wall saturation process a day before tuckpointing began,
