# WATER PENETRATION THROUGH MASONRY WALLS LABORATORY AND FIELD INVESTIGATIONS

Tom Hines, A.I.A.<sup>1</sup>, Madan Mehta, Ph.D.<sup>2</sup>

Original paper presented at the 6<sup>th</sup> Canadian Masonry Symposium, Saskatoon, Saskatchewan, Canada. June 15-17, pp. 429-437

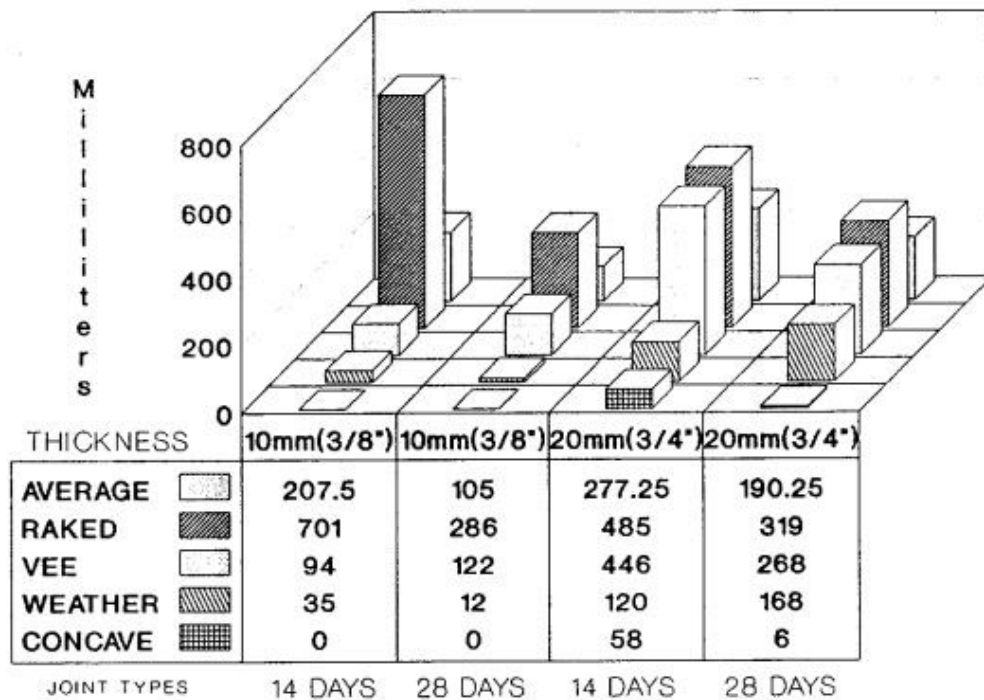
Experimental work at the University of Texas at Arlington resulted in data giving the rateability of mortar joint profiles in clay masonry of various commonly used joint profiles in resisting the penetration of water through the walls. The tests were conducted using ASTM E 514-86: "Standard Test Method for Water Penetration and Leakage Through Masonry Walls" (American Society for Testing and Materials, 1986). The materials used in the walls conformed to appropriate ASTM standard specifications; the mortar contained no admixtures. Tests confirmed the masonry industry's long-held recommendation that a concave joint is the most water resistant joint. More specifically, the work yielded the following rating of joint profiles in order of decreasing performance: concave joint, weather joint, vee joint, and raked joint, Figure 1.

Figure 1 - Relative performance of various joints at 14 and 28 days of age

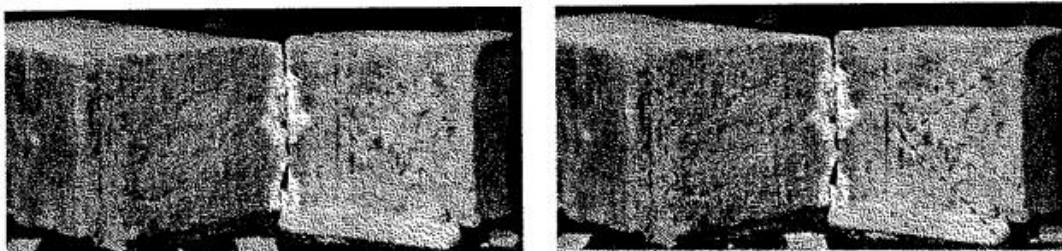
Figure 2 - Interior of a joint showing the leak hole and change of mortar profile

Visual and physical examination of the interiors provided insight into the details of the workmanship and the bond between the individual bricks on either side of the joint and mortar components. Figure 2 shows one such interior. The area to the right of the (<) in this figure indicates new mortar added to the tapped open joint. The line with a profile (<) is the intersection of the new mortar and water path. Dark areas in the figure indicate crystal growth that was apparently interrupted when the brick unit was moved and the joint opened, resulting in the loss of bond between the brick and the mortar.

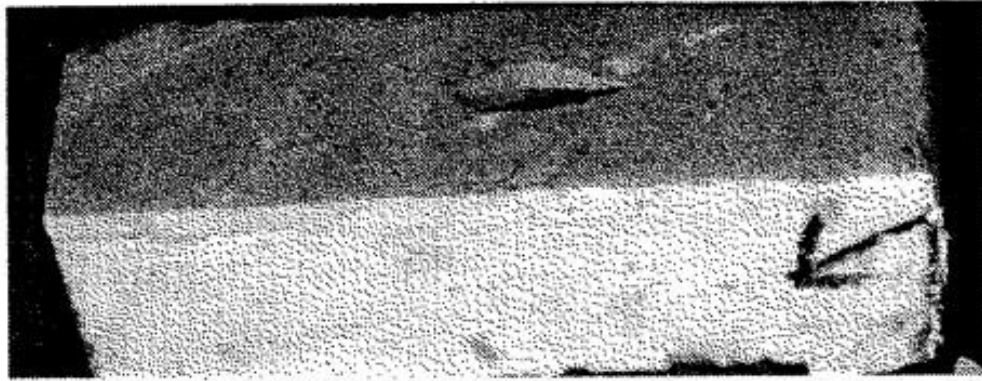
Figure 3 - Rear of unit showing position of the leak hole

Examination of the joint interiors yielded overwhelming evidence to indicate that even a tooled concave joint will leak when used with bricks with a high initial rate of absorption, (IRA), values and/or poor workmanship, particularly the latter. This conclusion has been supported by the author's personal observations of the techniques used by the two masons employed to build the walls. Their consistent tendency to move or tap the bricks after their initial placement resulting in pulling the mortar off the bricks and creating holes in the joints, Figure 3. Specific details and additional conclusions from this study have been reported elsewhere (Hines, 1991, Hines and Mehta, 1991). The above study was conducted in partial fulfillment of the Master of Architecture degree at the University of Texas at Arlington.

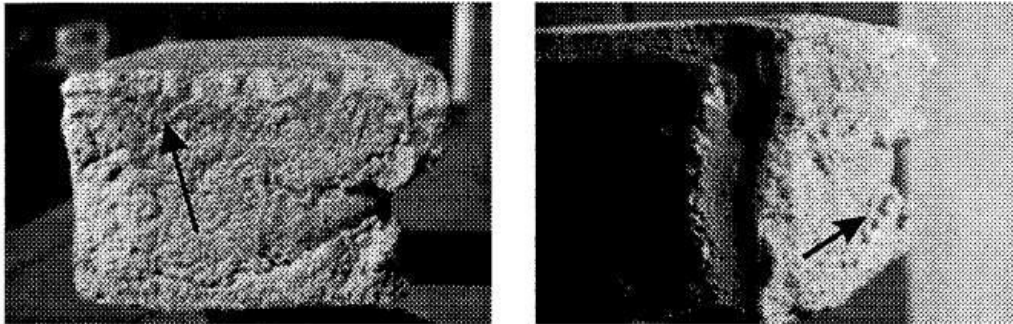
Figure 4 shows a head joint cut from a portion of the wall of the new building. The ease with which the bricks from either side of the joint came apart showed the lack of bond between the units and the mortar. Such would be caused either by the brick's high IRA

value and/or the poor quality of the mortar used. Note also the depressions on the surface of the mortar which indicates that the brick was either moved from its initial position and (possibly) additional mortar added to the joint or the mason did not use proper brick laying technique by exerting adequate pressure to yield a tight head joint.

Figure 4 - Sample of brick removed from Duncan Dining Hall

The University Physical Plant's estimate of the remedial work (Hines, 1992) is nearly \$250,000.00 dollars. The work would include total removal and proper installation of all the masonry work.

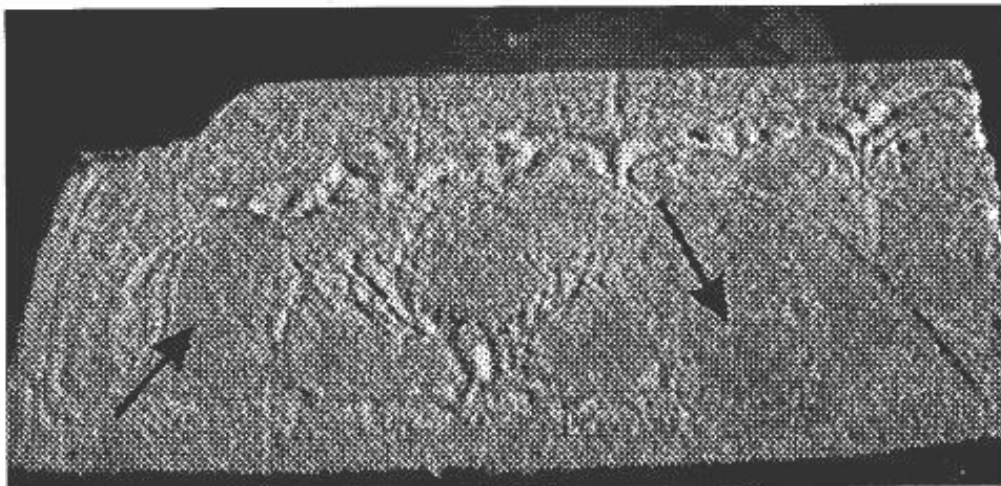
Figure 5 - Sample showing the bed joint. Note the color contrast indicated by the arrows. The shading indicates the location of crystals.

Figure 5 shows a bed joint extracted from another location in the same wall, indicating the same deficiencies as in the previous head joint. In a few other joints, the mortar was so deficient in quality that it powdered when rubbed with fingers. Investigations of the flashings indicated that the counter flashings incorrectly installed, Figure 6, and on the east side of the entry, the weep holes omitted.

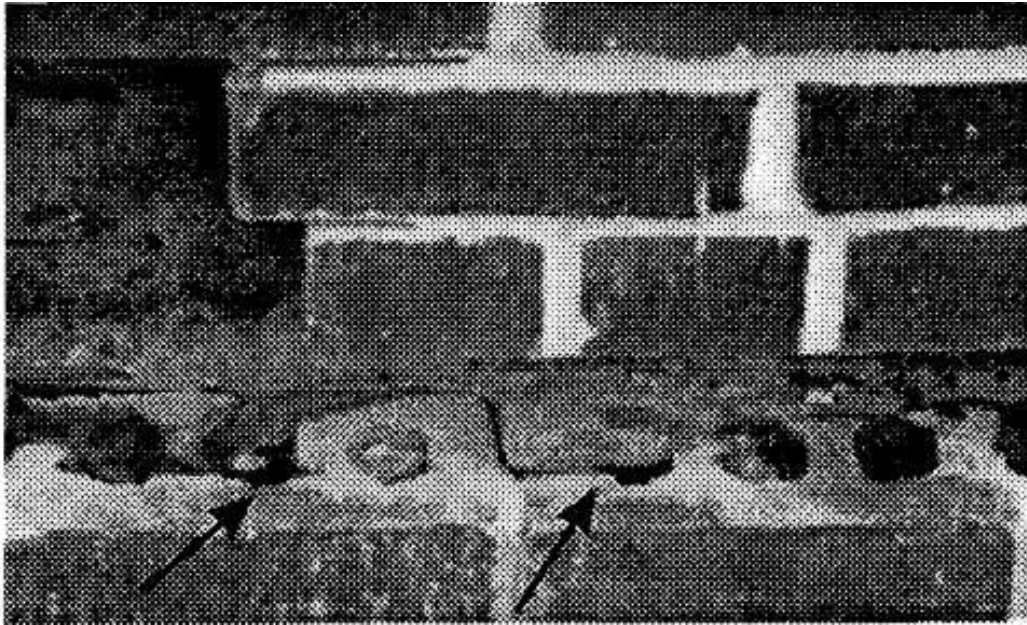
Figure 6 - Opening in the parapet wall showing flashings, brick and the mortar interface.

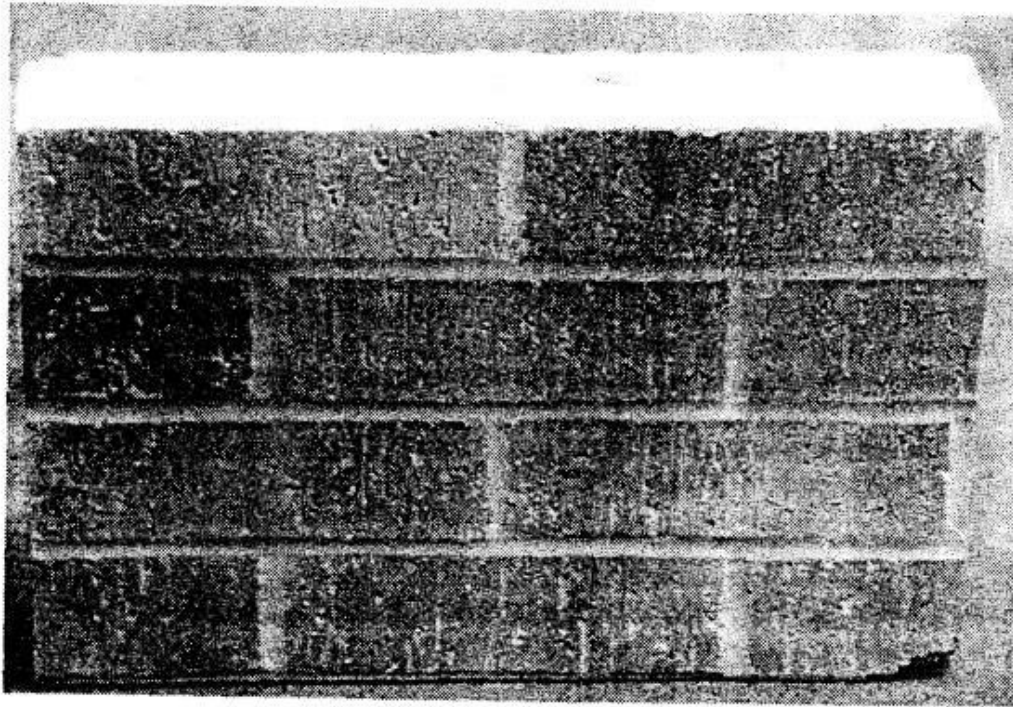
In the Fall of 1990, one year after completion, reports were received by Physical Plant regarding rainwater penetration through the second-floor glazing assembly of the Biosciences/Biophysics Building - a brick veneer clad facility. Several investigations were undertaken to find the cause of the problem. High pressure water tests on the glazing revealed defects in the brick veneer close to the glazing assembly. Subsequently samples of brick prisms were removed and revealed the following defects: (i) the flashing at the lintel level was poorly installed and (ii) the cavity space between veneer and the back-up was full of mortar droppings of up to one-half to three-quarters the height of the soldier course, blocking the escape of rain water through the weep holes. Figure 7 shows a removed masonry prism revealing poor workmanship similar to that of Duncan Dining Hall Addition.

Figure 7 - Brick veneer prism removed from Bioscience/Biophysics exterior.

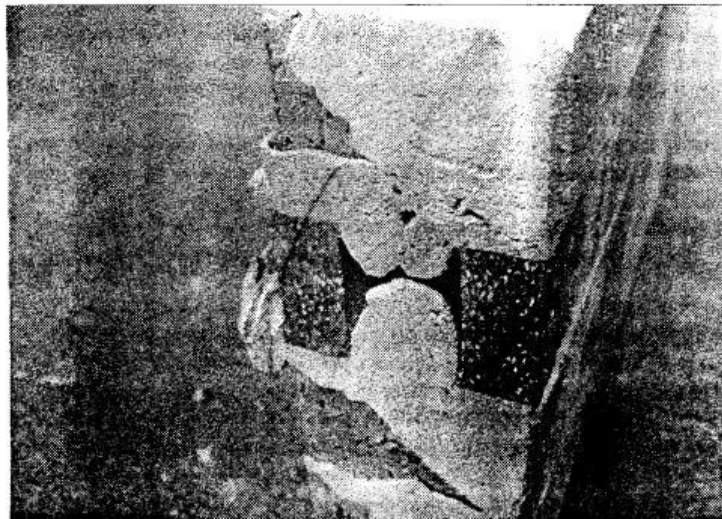
The prism shows voids in the head joints, Figure 8 and several boat shaped depressions in the bed joints, Figure 9. In view of these findings, the Physical Plant is considering an impulse radar scan, (Abrams and Matthys, 1991) of the entire building to locate areas of probable future leakage so that all necessary repairs may be undertaken at one time. Repairs include complete removal and proper construction of all the masonry work. The total estimated cost is US \$750,000.00 (Hines, 1992).

Figure 8 - Rotated exposed head joint showing separation between the mortar and the brick.

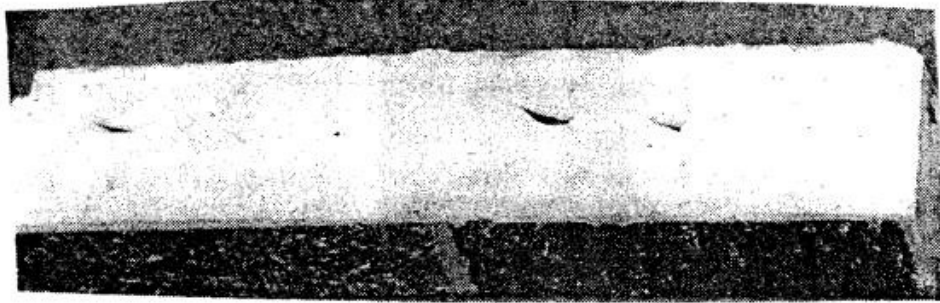
Figure 9 - Bed joint showing boat-shaped leakage holes
