Stabilization and Repair of the City Café Hearne, Texas

A Case for SIP (Stabilize-In-Place)
vs.
ROAR (Rip-Out-and-Replace)

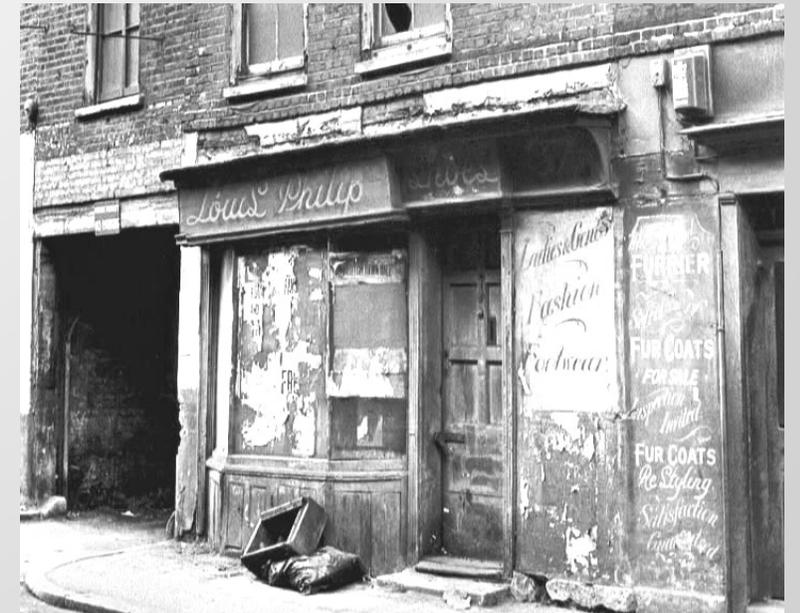
The preservation of Texas Style Older Buildings is a one-way street. There is no chance to renovate or save a historic site once it is gone. And we can never be confident about what the future values. This reality highlights the importance of locating and protecting landmark significance - **like a headstone marks a grave, buildings once destroyed and lost only a faded memory remains** Figure 1.

Figure 1 – Buildings soon to be lost!

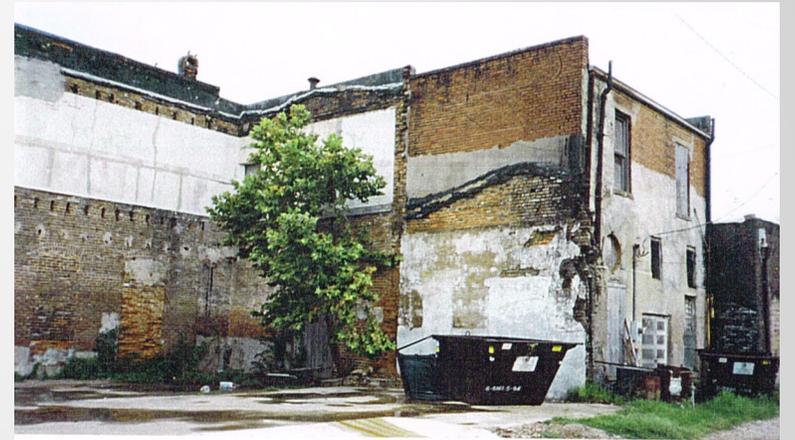
Figure 2 – Exposed side walls circa 1995

- The North and East side walls have severe deterioration of the brick resulting from years of unprotected exposure – Figure 2.
- The asphalt and gravel roof membrane is at least thirty (30) years old and failing - Figure 3.
- Bitumen parging applied the parapet walls as a measure to halt water leakage into the building. Years in the Texas sun cooked the material to the brick imparting additional repair when removed.
- Repair of the masonry walls (replace the damaged brick and point with new mortar) could not be completely accomplished with the available budget.

- Repair of the masonry walls (replace the damaged brick and point with new mortar) could not be accomplished with the available budget.
- The alternative solution is the applying one (1) inch of urethane SPF with an acrylic topcoat – Figure 6.
- At completion, the walls remain dry and force the moisture in the brick to the inside of the building – Figure 7.
- Fans exhausting air from the unoccupied spaces and air conditioning in the occupied spaces, removed all the moisture in six months.

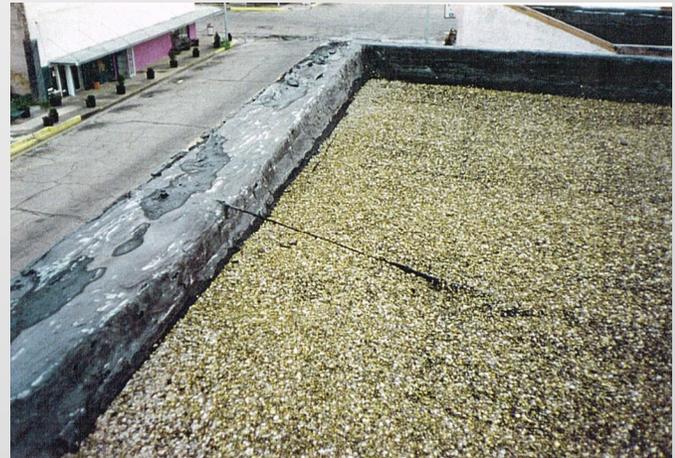
Figure 3 – Partial roof circa 1995

- Removed the existing roof membrane, exposed and repair damage.
- New urethane SPF coating two (2) inches thick and twenty (20) mil white acrylic coating.
- The system manufacture provided a **ten (10) year warranty** with an additional ten (10) year option.

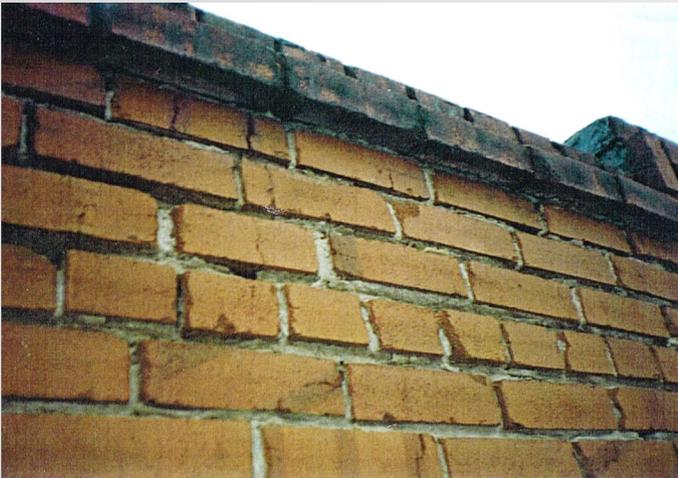
Figure 4 – Adjacent parapet wall

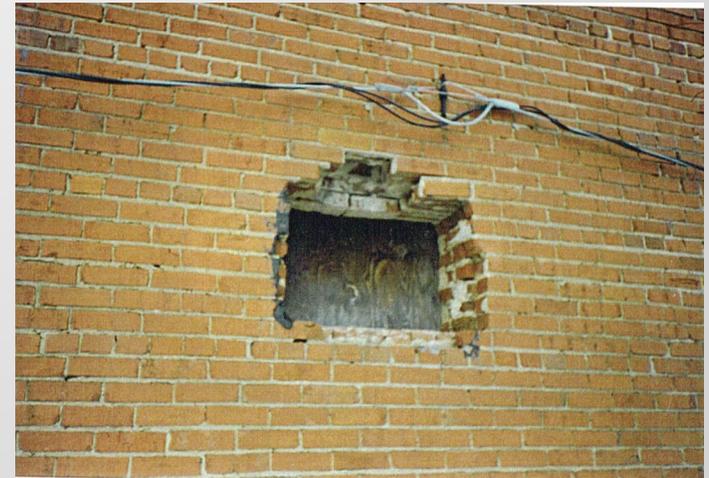
Figure 5 – Adjacent parapet wall

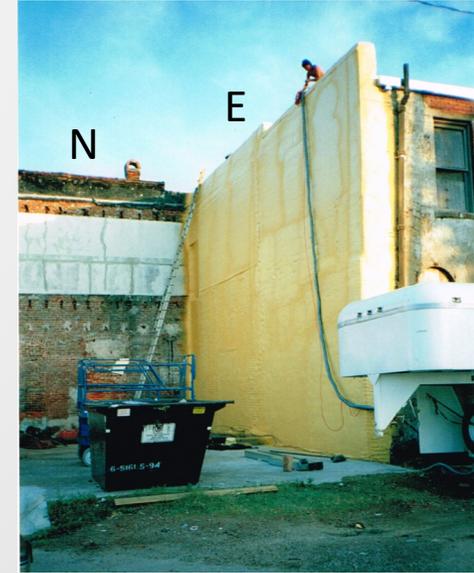
Figure 6 – East wall with SPF

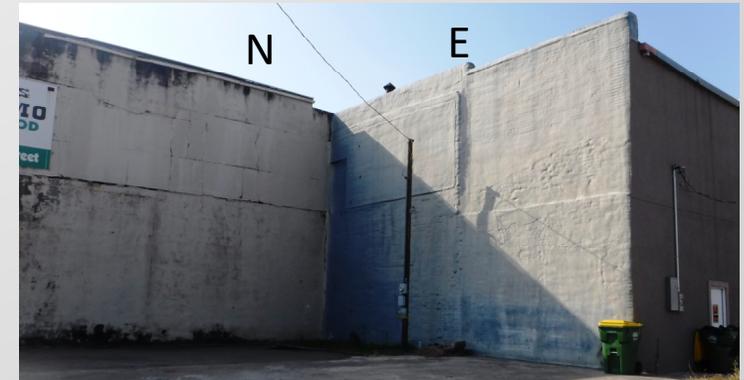
Figure 7 – East and North Walls Repaired

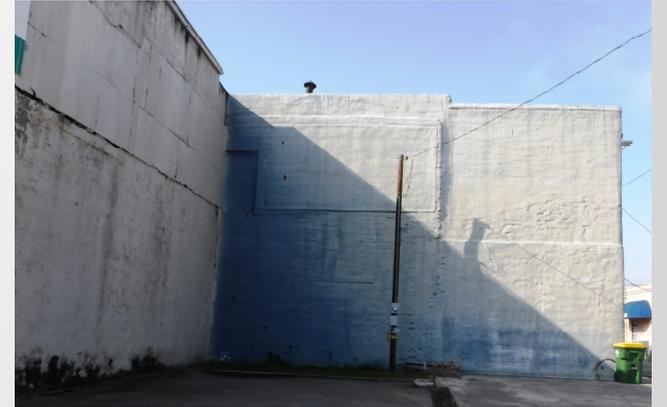
- Twenty-four years after applying the urethane foam on the vertical surface of the masonry walls, there is no indication of failure or fatigue.
- The foam acts as shrink-wrap, contributing to the integrity of the masonry systems.

Figure 8 – Repaired Walls
