Water Penetration Through Masonry Walls Field Investigation

Biochemistry – Biophysics Building
Texas A&M University

This Case Study investigates the Owner's concerns with water entering though the brick veneer and glazing systems one year after the completion of construction.

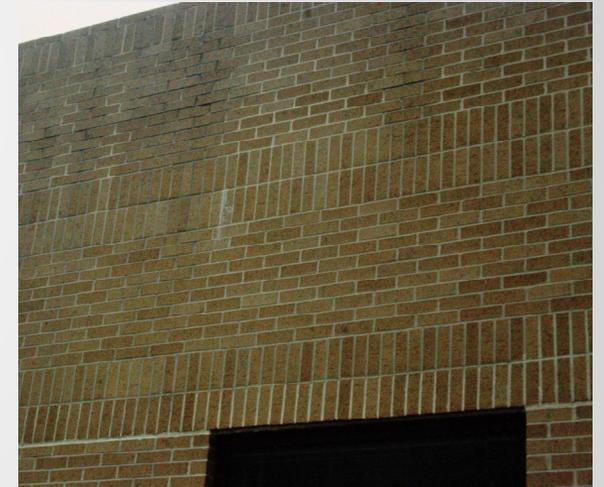
- The building opened for occupancy in the Fall of 1995, and an area of over 60,000 square feet.
- Four floors above the ground floor consisting of classrooms, lecture halls, dining facilities, faculty offices, and laboratories.
- Various areas of the building's facade displayed staining and efflorescence as evidence of water entering and exiting the brick veneer cladding.
- The building's main entry faces north is subject to wind-driven rains forcing large quantities of water through the brick and into the building.

Figure 2 – Stains from water intrusion

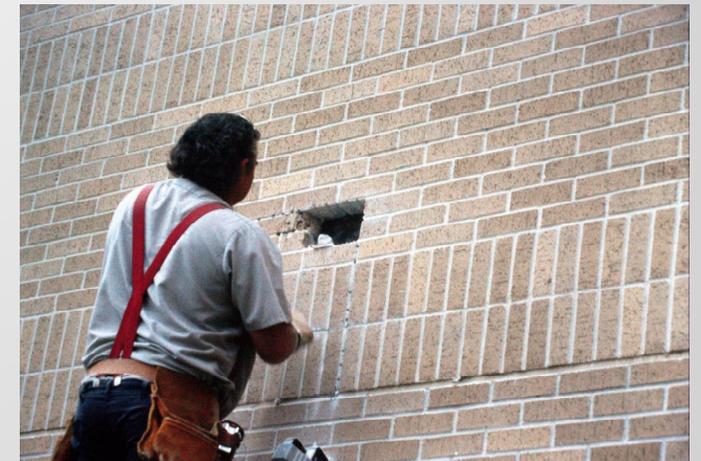
Figure 3 – Opening above the soldier course.

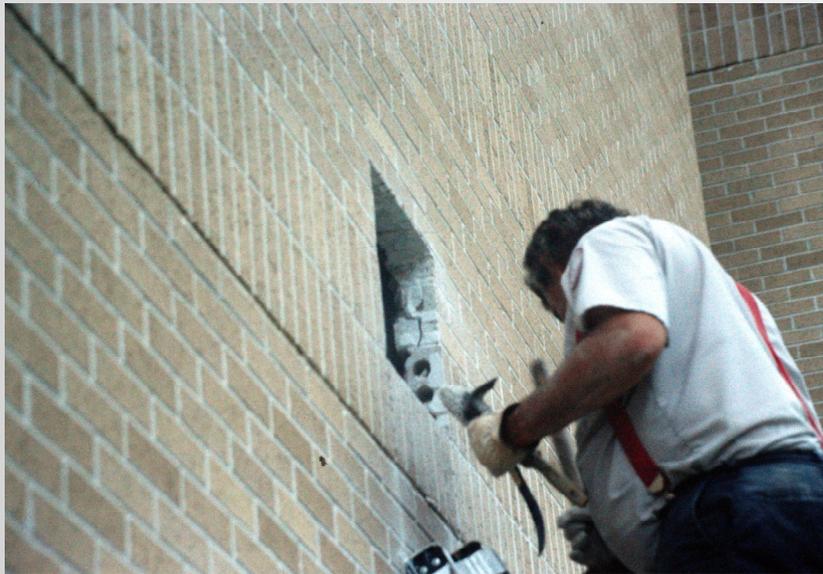
Figure 4 – Opening at the floor belt course.

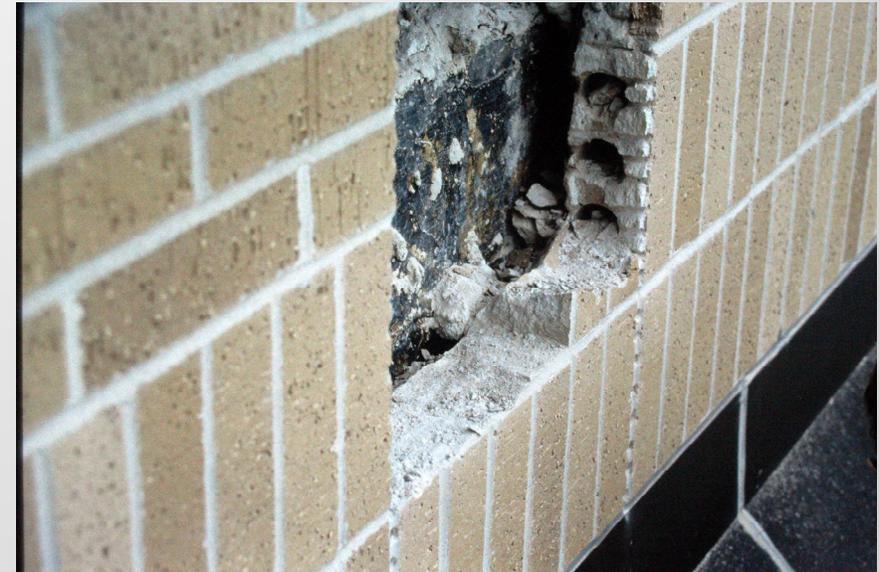
Figure 5 – Opening at the floor belt course.

- Wall Cavity - Figure 5
 - ❖ The cavity (space between the brick and the wall sheathing) has mortar debris and partially clear. Water collects and impeded from leaving the cavity through the weep holes.
- Wall Cavity - Figures 12 and 13.
 - ❖ The cavity has mortar debris full and not clear up to one-half to three-quarters the soldier course's height. Water collects and blocked from leaving the cavity through the weep holes.
 - ❖ The flashing, at the lintel level is improperly installed.

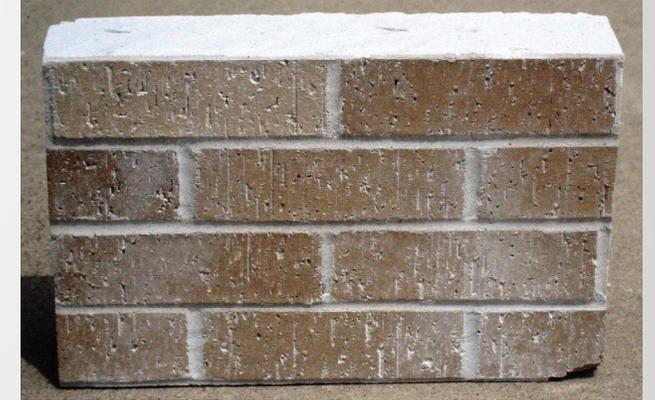
Figure 6 – Front of typical prism

- Front Side - Figure 6.
 - ❖ Looks good. Implying the same attention and care for all facets of the masonry work complies with the architect's specifications. The brick is clean and laid using and 3/8" tooled concave joints.
 - ❖ Boat-shaped holes in the bed joint.
- Back Side - Figure 7.
 - ❖ An abundant amount of mortar protrudes from the bed joints.
 - ❖ There are marginal amounts of mortar in the head joints.
- End - Through the Head Joints - Figure 10.
 - ❖ Boat-shaped holes in the bed joint and a fresh-mortar line (emphasized in black).
 - ❖ There are marginal amounts of mortar in the head joints, some with mostly void.

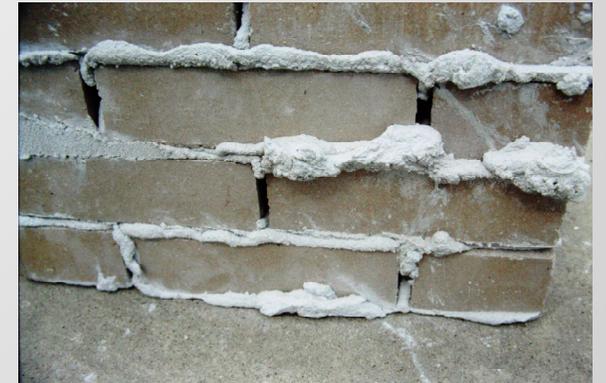
Figure 7 – Back of typical prism

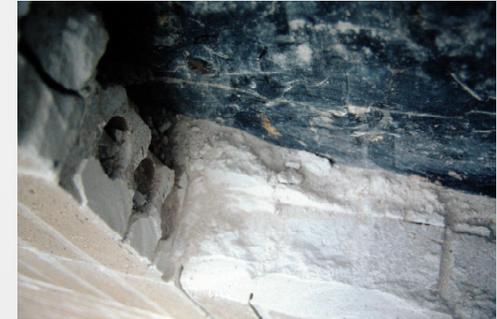
- Third Step – Investigate the openings in the walls and observe the cavity and flashing assemblies.
 - ❖ Supported by the steel floor angle, two (2) soldier courses define the belt-course on every floor.
 - ❖ Typically a two-part steel flashing assembly diverts water collected in the cavity to the openings in the mortar joints called weep-holes. The wall-cavity should be clear of mortar and the back-side of the brick veneer clean of mortar so as not to catch water.

Figure 8 – Wall cavity at the belt course

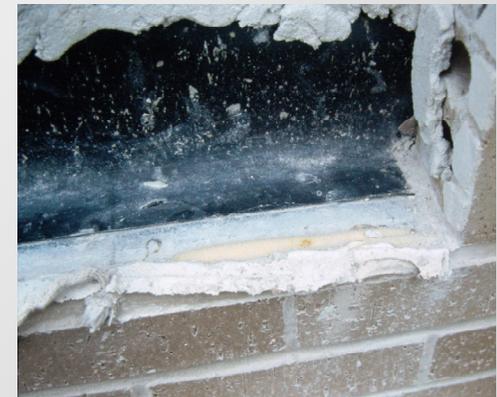
Figure 9 – Wall cavity at the belt course

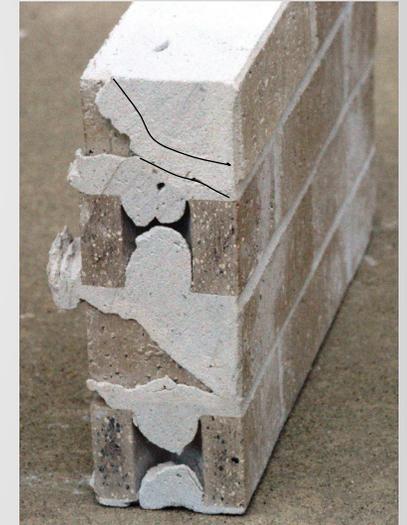
Figure 10 – Head joints

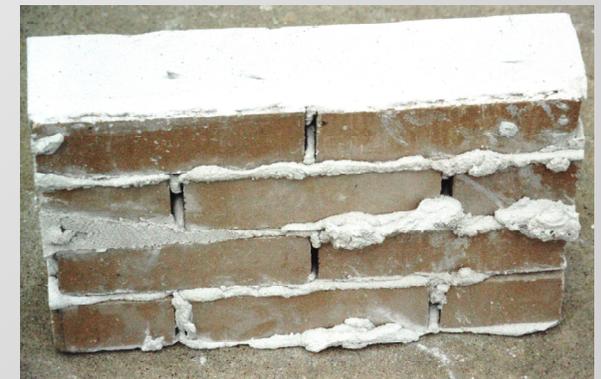
Figure 11 – Back of typical prism

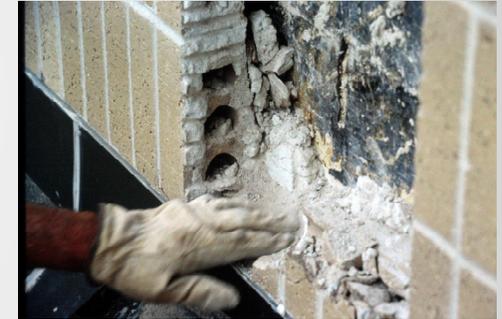
Figure 12 – Wall cavity at the belt course

- Expecting to discover some flashing details poorly constructed, the extent across the majority of the building walls was troubling.
- The recommended solution is to remove all the brick veneer cladding, flashing assemblies; repair damages, and properly install the brick veneer cladding as originally specified by the architect and bid by the general contractor.

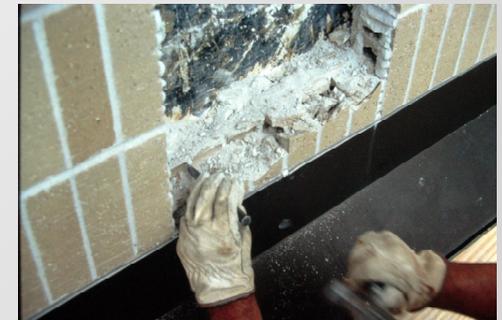
Figure 13 – Wall cavity at the belt course
