Lighting and HVAC Modifications Riverbend 1 Office Building Fort Worth, Texas

Reduction in the Costs of Operation through
Energy Management and Efficiency

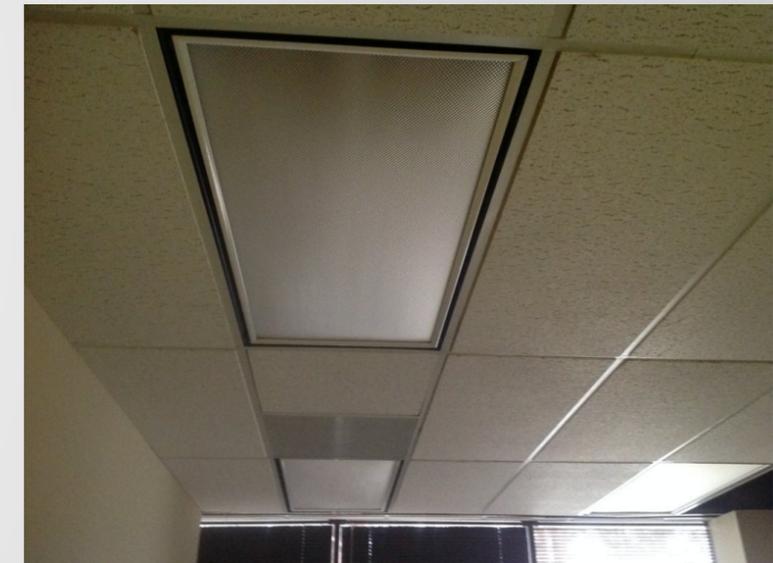
Figure 1 – Florescent Light

- Interior Suspended Ceilings - 2'x4' recessed florescent 4-bulb fixtures for the interior and HID recessed can-lights for the lobby ceiling - Figure 1.
- Exterior building lighting - 8" recessed soffit fixtures with metal halide bulbs;
 - ❖ Parking lot lighting - Pole lights with high-pressure sodium fixtures.

- ❖ Phase 1 - New LED fixtures replaced existing Metal Halide fixtures and the addition of three new poles - Figure 3.
 - * Nine 200 watt fixtures on poles.
- ❖ Phase 2 - New LED fixtures replaced the Incandescent and Metal Halide fixtures for the building perimeter fixtures.
 - * Sixteen ten (10) watt fixtures
- ❖ Phase 3 - New LED fixtures replaced the 2'x4' four bulb florescent fixtures for the building fixtures.
 - * Two hundred twenty (40) watt fixtures.

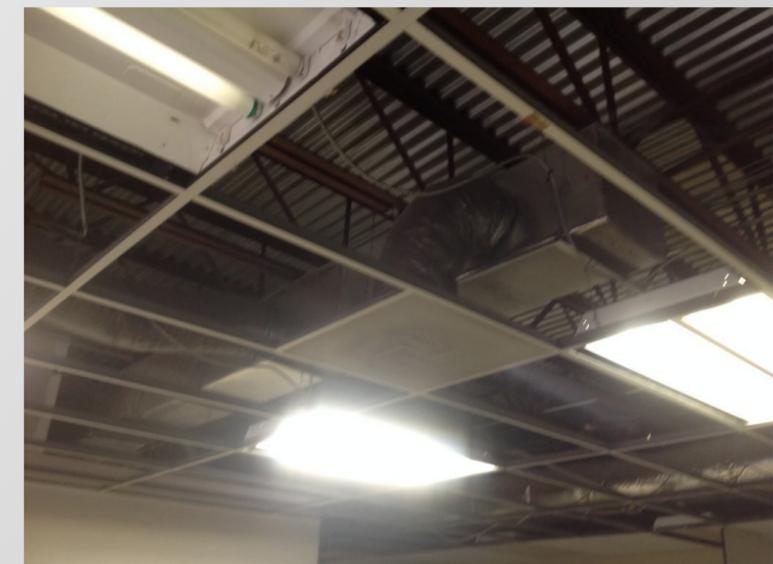
Figure 2– Old VAV ATU

- Two Roof-Top Unit (RTU) air handlers, one for each floor. Each 50 tons capacity.
- Floor air distribution - an approximate total of 41 Fan Powered Variable Air Volume (FPVAV) and 4 VAV air terminal units (ATUs).
- Each ATU is controlled with an individual thermostat. No system controls or Building Automation System (BAS).

- Phase 2 - Replace the Air Terminal Units (ATUs).
 - ❖ Original to the building's construction, all the ATU's had various operation levels from not-at-all to operate without controlling the intake air damper. The supplemental heat strips, for many units, did not work or were missing. The units with working heat strips had no control of the internal fan. Heating was accomplished by diverting warm air from the building's interior zones to the exterior zones.

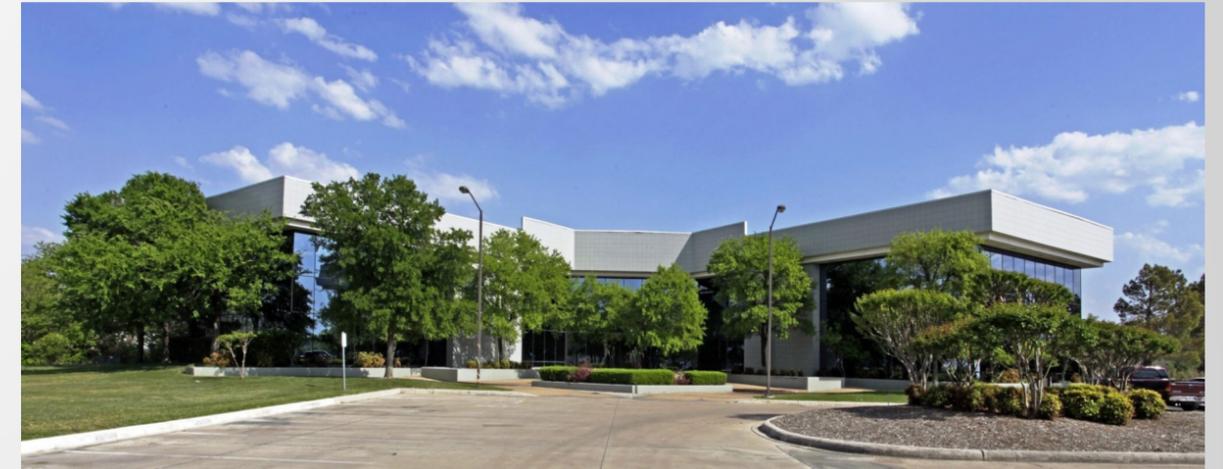
Figure 5 – Front of Riverbend 1

- ❖ The North side is affected by landscape surfaces and affected by the concrete parking lot.
- The majority of the building's facade is a single glaze bronze glass curtain wall.

- Upgrading the HVAC system required redesigning the equipment (ATUs) sizes for the various site condition effects on the building's exterior glass walls.

- ❖ During the Fall, Winter, and Spring months, the Westside experiences heat gain due to the low sun angles. Portions of the building exposed to the parking lot require cooling, while the Eastside, shaded by the trees, and minimal direct sun, require heating.

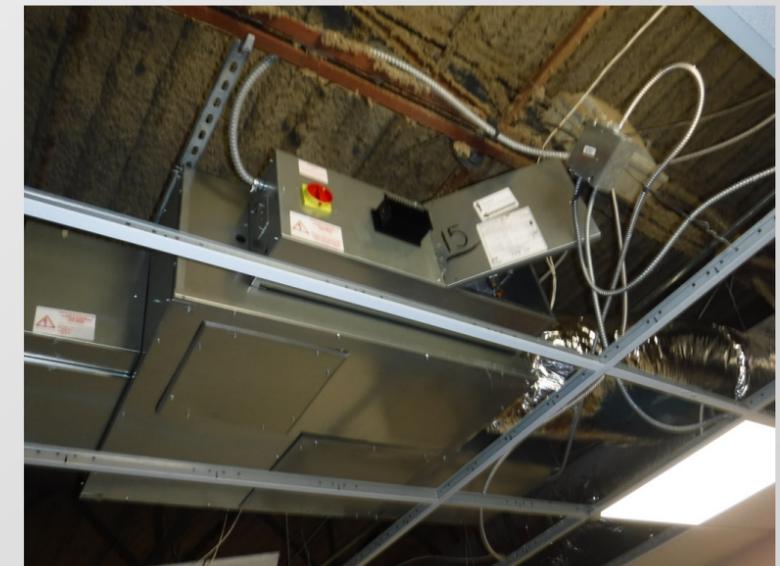
Figure 6 – New FPVAV ATU

- ❖ Phase 1 - New Building Automated System (BAS)
 - * RTUs - Augment the manufacturer's controls.
 - * Removed the old pneumatic system from each ATU and install digital remote control system.
- ❖ Phase 2 - Replace the old, broken, and outdated ATUs with new, energy efficient systems with digital controls.
 - * Modifications to the existing duct-board ductwork and replace the old supply and return air grilles.

- Air Flow - The BAS controllers for each ATU operate the damper and vary the speed internal fan motors (during the heating seasons) ensuring air flow at the perfect level throughout the suite. Varying the fan speed increases the static pressures in the ducts, resulting in appropriate volume of air at each register.
