DIFFICULTIES ENCOUNTERED AND SOLUTIONS DEVELOPED IN RESTORING MASONRY BUILDINGS - INVESTIGATION OF FIVE SIGNIFICANT BUILDINGS

Tom Hines

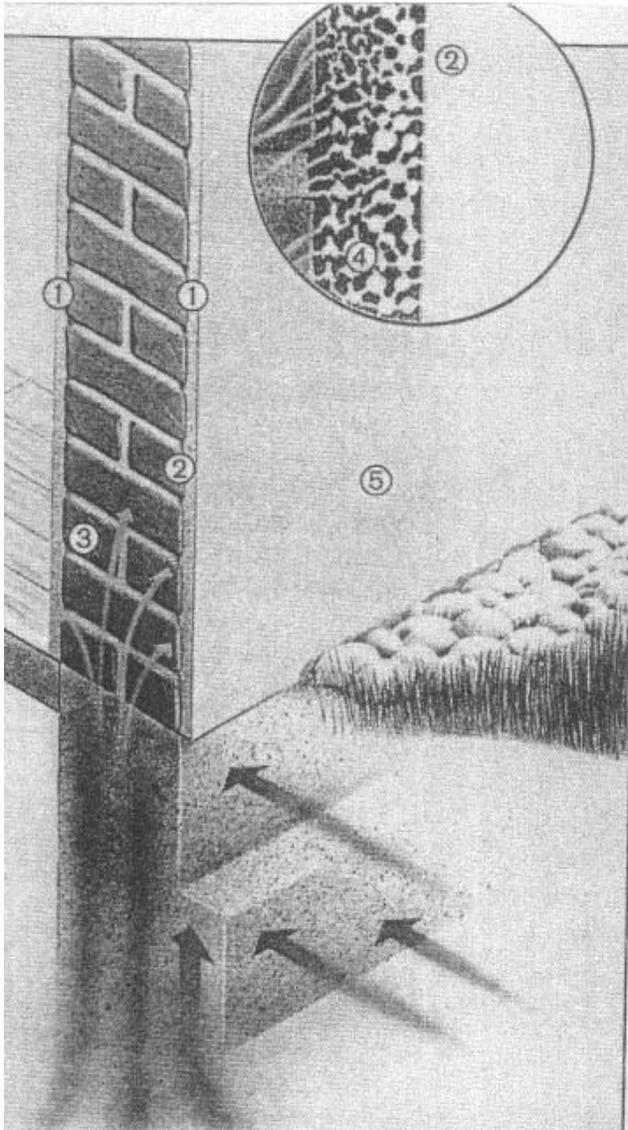
Figure 7 - Characteristics of BAYOSAN Plaster under water load.

1. BAYOSAN redevelopment plaster is layered onto a section
2. Quick and easy evaporation due to pore-structure
3. Zone of moisture is lowered
4. Crystallization of salt within the pores and without damage
5. Plaster and Paint keep perfectly dry and clean

The benefits of using redevelopment plaster are [Figure7]:

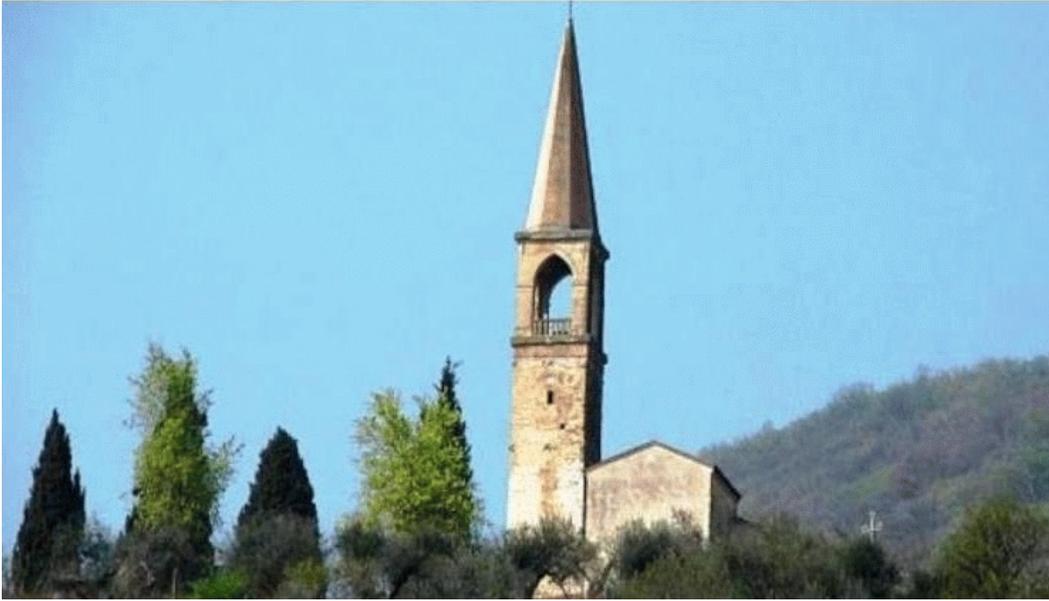
Figure 13 - View of the Ancient Nanto Church Bell Tower

Primary issues concerning this 11th century tower [Figure 13] were:

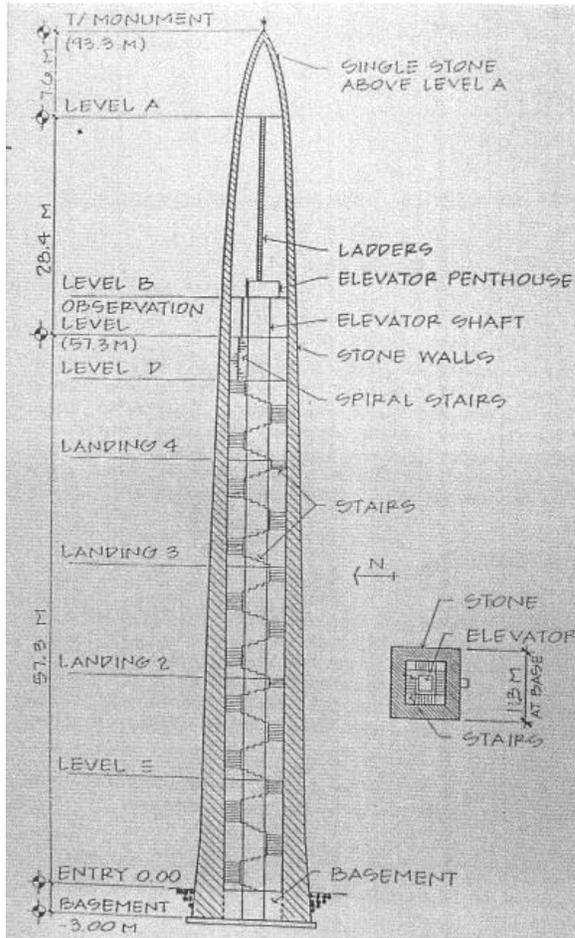
Figure 17 - Monument section

The base of the monument is approximately 37 feet square. The walls taper from a thickness 7 feet 6 inches at the base and 2 feet at the top [Figure17]. The structures tapers inward in height and width. Since its dedication the monument has under changes in, ownership, maintenance, and repairs and physical condition as indicated here:
